LEVEL 3
SITE INSPECTION PRIORITIZATION

BISHOP TUBE COMPANY SITE FRAZER, CHESTER COUNTY, PENNSYLVANIA

ARCS CONTRACT NUMBER 68-W8-0092
WORK ASSIGNMENT NUMBER 92-31-3JZZ

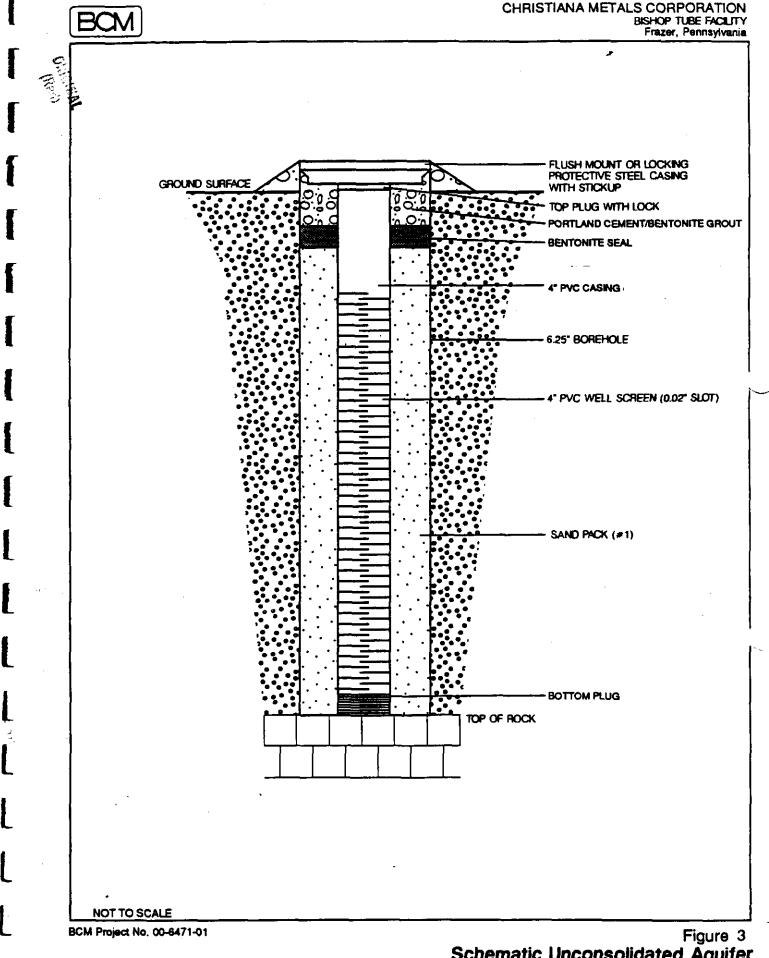
Figure 3
Schematic Unconsolidated Aquifer
Monitoring Well Construction Diagram

Generally, each monitoring well was constructed with approximately 10 feet of 4-inch ID, threaded flush joint, 20-slot (0.020 inch), Schedule 40 PVC screen, and 4-inch ID, threaded flush joint, Schedule 40 PVC casing (riser). After inserting the screen and casing, a sand pack of No. 1 Jessie Morie silica sand was installed in the annular space from the bottom of the borehole to approximately two feet above the screen. An approximately 2-foot thick bentonite pellet seal was installed immediately above the sand pack. The bentonite seal was moistened with water if it was above the static water level and allowed to sit undisturbed for approximately 10 minutes to allow the bentonite to expand and seal the borehole.
